WADC TECHNICAL REPORT 53-192

## MECHANISM OF RAIN EROSION

Part XI. Effect of Residual Stresses and of Molding  
Variables on the Erosion Resistance of Nylon

NATIONAL BUREAU OF STANDARDS

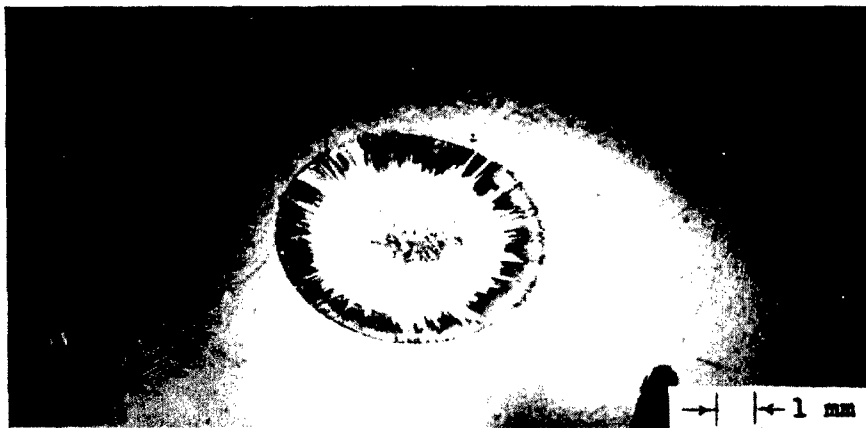
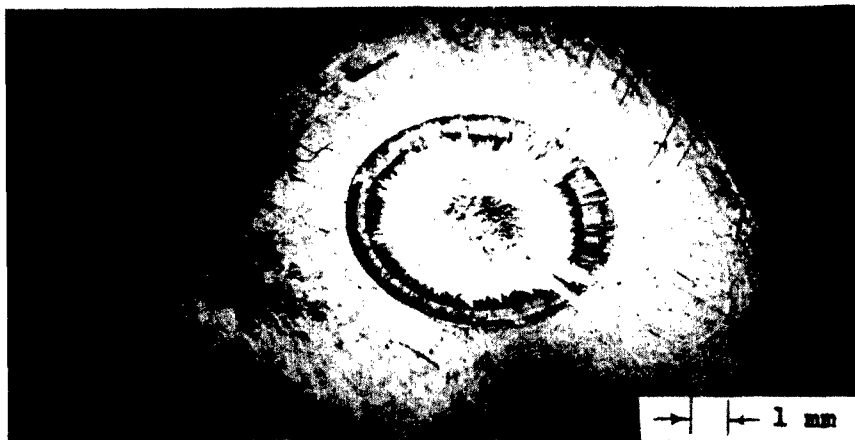
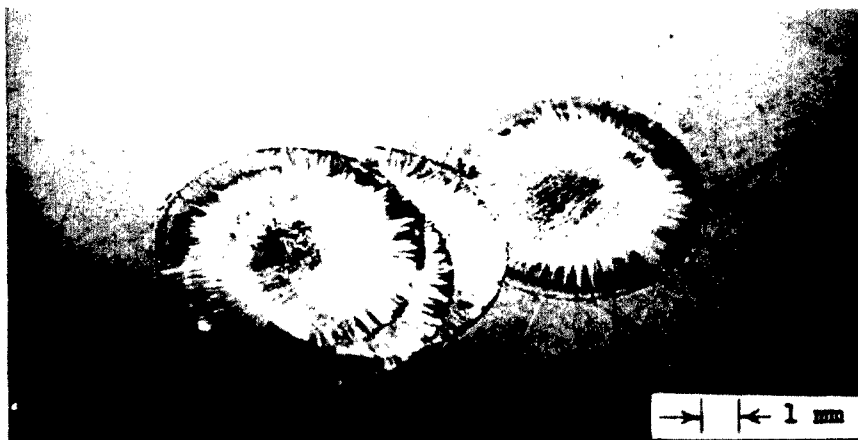
FIGURE 1. SINGLE AND MULTIPLE SHOTS ON NYLON FM-10001 WITH DEFORMING  
LEAD PELLETS

A test of the nylon sheet was also made using deforming lead pellets that were fired from the Benjamin air rifle. Deforming lead pellets that were fired against it at velocities of 490 ft/sec, 530 ft/sec, and 640 ft/sec left small circles of abrasion but produced no cracks. See Figure 1. No cracks were produced even on multiple impingement with lead pellets at a velocity of 490 ft/sec. See Figure 1(c). Inspection at X62.5 magnification of the structure of the dim circle made at the impingement velocity of 530 ft/sec showed that it consisted of very fine lines in the radial direction. See Figure 1(a). These lines may have been caused by the drag of the deforming lead over the surface of the nylon as the lead pellet flowed radially during the collision. The damage mark made in the nylon by a deforming lead pellet at an impingement velocity of 640 ft/sec consisted of a very shallow depression and a circle of abrasion. See Figure 1(b). In the case of neoprene coatings, the damage produced by the impingement of deforming lead pellets often consists of a circular cut surrounded by a coating-bubble.

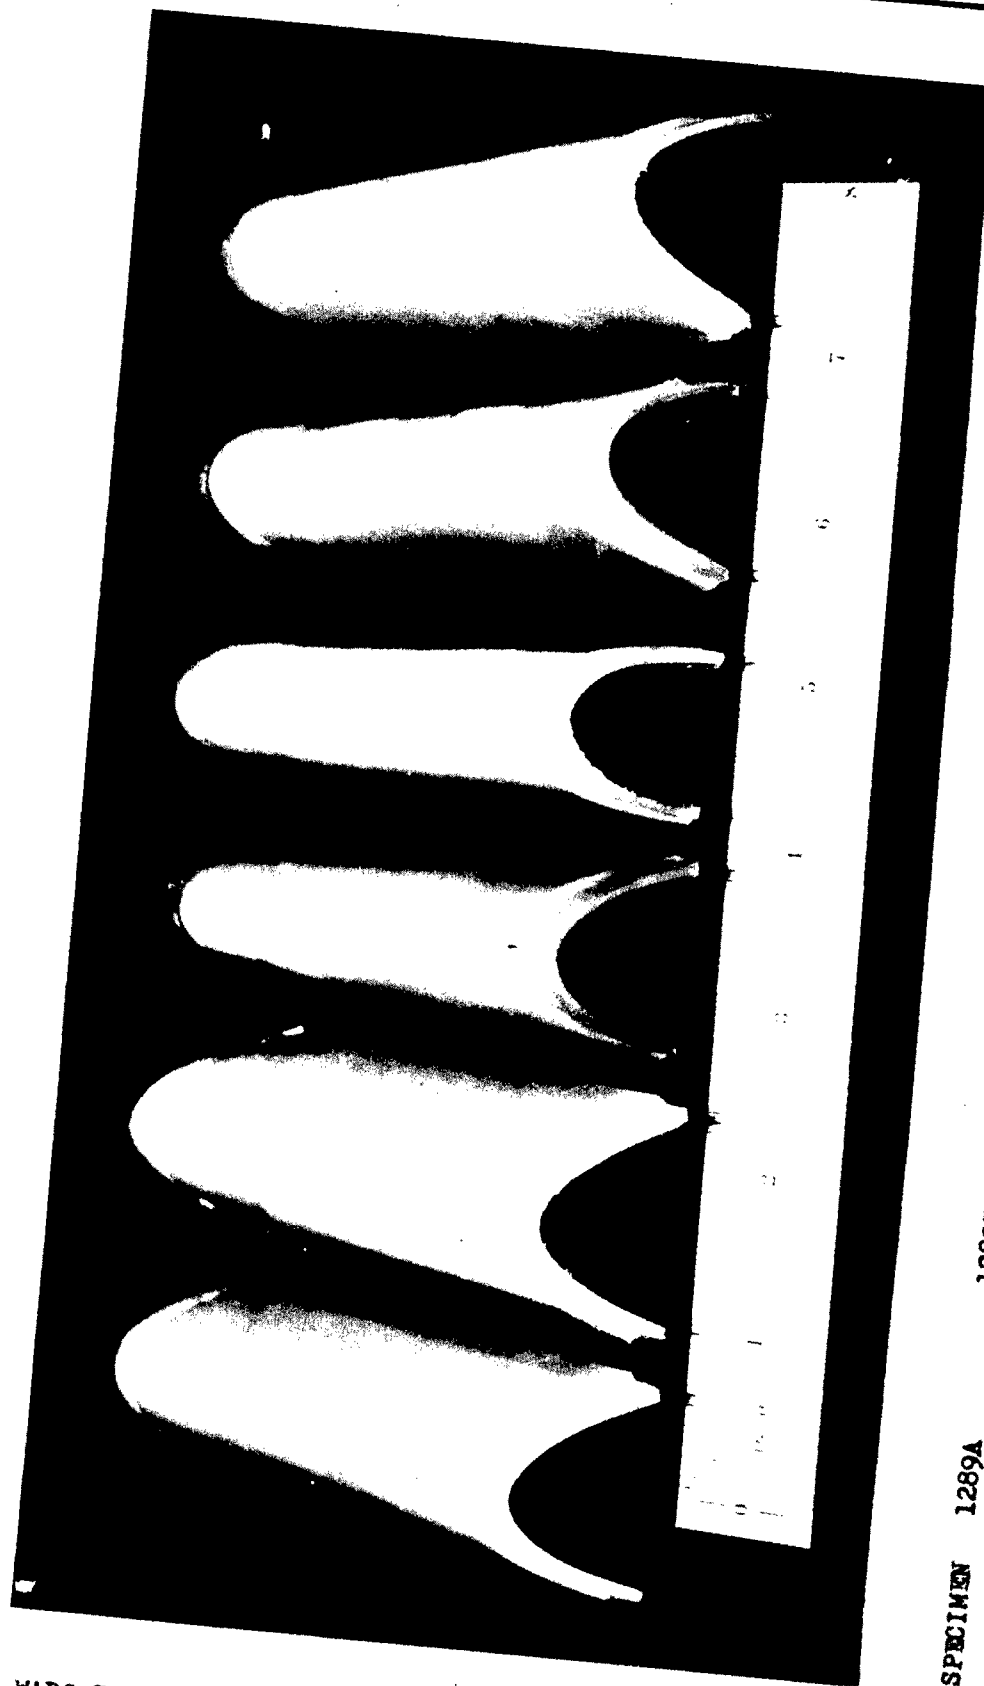
FIGURE 2. SPECIMENS OF NYLON PA-10001 AFTER VARIOUS TEST INTERVALS. STUDY II.

Inspection of specimen 1289A and 1289B at X25 magnification revealed that specimen 1289A was more severely damaged after test for 25 sec than specimen 1289B was after it was tested for 1 min under the same conditions of velocity and rain rate. This paradoxical result is in agreement with the observation that specimen 1289A had suffered the most extensive color change during molding. It was observed that the leading edge of specimen 1289A was checked with closely spaced cracks. The cracks were, in general, essentially parallel to one another; connecting cracks also were evident; material had chipped away along cracks and between cracks. This crack structure existed on the leading edge and extended a short distance down each side of the specimen. See Figure 3(c). The more or less parallel cracks did not run along the length of the specimen but were oriented at an angle across the leading edge. Observation of the crack structure down the length of the

In addition, three of the specimens had changed contour due to creep since the time that they were formed. Only specimen 1345B retained the 1-in. chord dimension of a Cornell Aeronautical Laboratory rain erosion specimen. See Figure 2.

Contrary to expectations, all of these specimens were in a serious state of damage. Each contained a wide swath of erosion down the full length of the leading edge. The exposed underlying layers of the material were close to the original color of the nylon. As in the case of specimen 1289A of Study I, this indicates that excessive heating during molding was restricted to the layers at or close to the surface.

Specimen 1345A was tested for 5 min. The outer distance from one side to the other at the base of this specimen had increased from the original 1 in. to 1-1/4 in. The surface layers of the entire specimen had turned from the ivory color of the original plastics sheet to a distinct light brown due to excessive heating during forming. A swath of severe erosion damage ran along the leading edge from one end to the other of the specimen. The erosion in this swath, which was nearly 1/2 in. wide, was advanced but appeared to be of a finer texture than that on the specimens that were eroded

Specimen 1345B was tested for 15 min. It was the only nylon specimen that did not change shape due to creep. See Figure 2. The surface layers of this specimen along the leading edge and to a distance about half-way down the sides of the specimen had been discolored to a light tan by superheating during molding. However, a large part of the embrittled tan layer had been removed by the waterdrop impingement of the rain erosion test, and only the fringes of it remained about half-way down each side. The large areas

Specimen 1346A was tested for 20 min. It had changed shape due to creep since it was formed so that the 1-in. distance from side to side of the specimen had increased to 1-1/4 in. See Figure 2. The entire surface of the specimen was a strong tan or light brown color. It was, however, not quite as dark as specimen 1345A. The glossy tan surface layer was removed by waterdrop impingement during the rain erosion test from an approximately 3/4-in. swath down the length of the specimen on the leading edge. Severe erosion, which had progressed further than on specimen 1345B, was restricted to the center of this swath. The light-colored plastics along the boundaries of the swath from which the embrittled tan layer had been removed had a dull but relatively smooth surface as on specimens 1345A and 1345B. The outline that remained of the originally raised disk of plastics, which marked the location of the orifice through which the original plastics sheet had been injection molded, could be seen on the inner surface at the edge of one side. The same type of stress-crack formation could be seen as that observed on specimens 1289A, 1345A, and 1345B. At one end of this specimen stress-cracks could be seen in a narrow band which had been protected from the rain impacts. This band extended across the leading edge. This observation indicates that the stress-cracks were present before the specimens were tested.

extensively by creep and in that it was discolored only to a pale yellow. It differed widely from these specimens, however, in the extent to which it was damaged by the waterdrop impingement. The glossy surface layer was removed from a swath that extended down the length of the specimen on the leading edge and that, at the high-speed end, was about an inch in width. A swath of very severe damage which was about 1/2 in. wide ran down the center of the swath from which the glossy surface layer was removed. The outline of the originally raised disk, which marked the location of the orifice through which the sheet of nylon had been injection molded, was on the inner surface of the specimen at the edge of one side. Examination of the specimen at X25 magnification revealed crack formation similar to that which was observed on all of the other nylon specimens of Study I and Study II with the exception of specimen 1289B.

The specimens of Study II were weakened toward erosion attack in three ways. First, they were molded from sheet material that contained residual stresses; the result of this was stress-crazing in the surface of the specimens. Secondly, the color change on the surface of these specimens indicates that they were exposed to excessive heating during forming, making it possible that the surface layers possessed properties different from those of the high strength nylon FM-10001 plastics; embrittlement of the surface layers may have resulted so that these layers may have been more easily subject to being cracked or chipped away from the remainder of the specimen in the same way that a thin brittle coating applied to a rain erosion specimen-base is chipped away. Finally, tensile and compressive stresses were molded into the specimens as is indicated by their deformation. If the surface layers contain internal tensile stresses during the rain erosion test, they are subject to higher stresses than unstressed material would be during test.

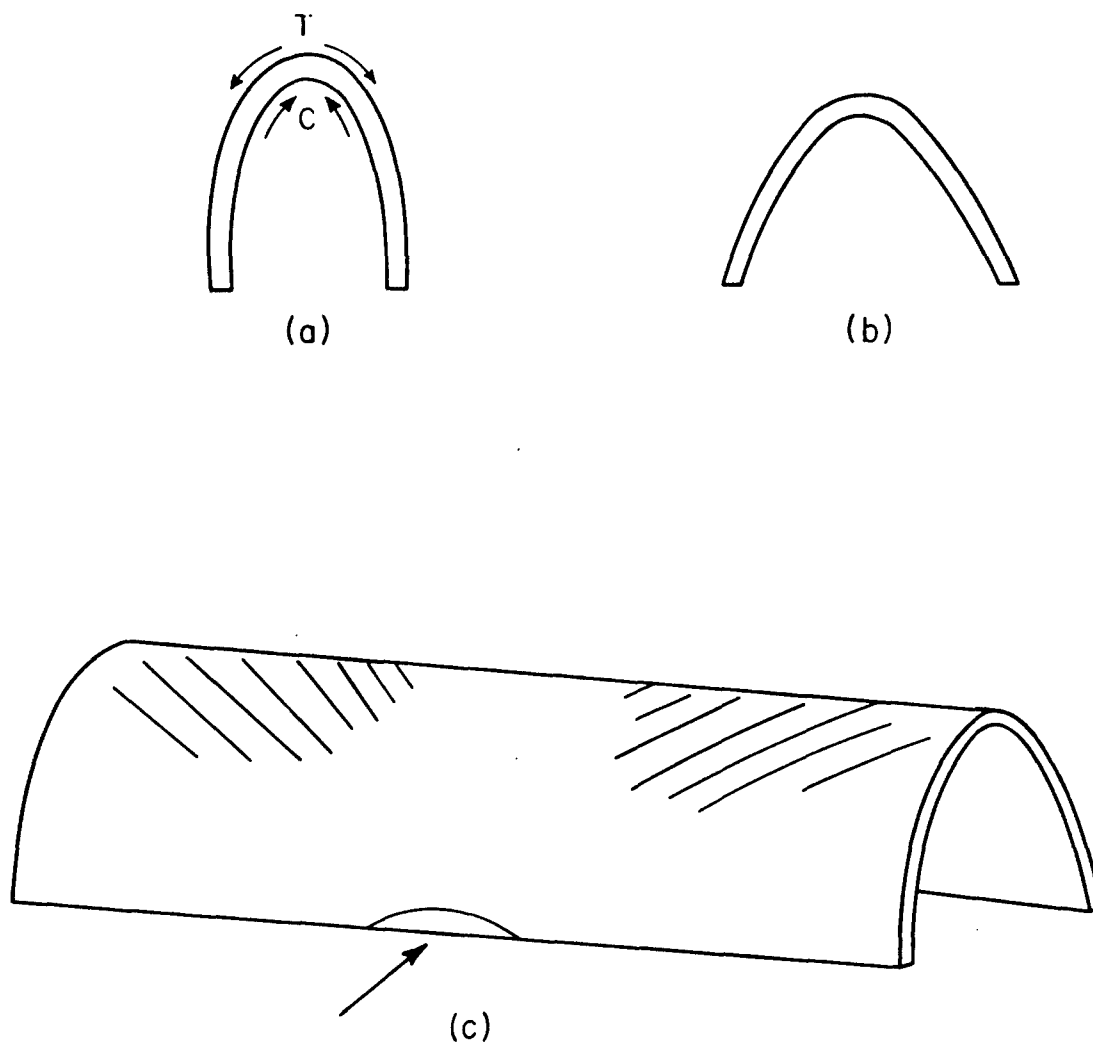
FIGURE 3. (a) SCHEMATIC REPRESENTATION OF TENSILE (T) AND COMPRESSIVE (C) STRESSES MOLDED INTO A RAIN EROSION SPECIMEN

(b) RELAXED STATE OF THE SPECIMEN AFTER CREEP HAS OCCURRED

(c) LOCATION OF STRESS CRACKS WITH RESPECT TO THE POSITION OF THE ORIFICE (ARROW) THROUGH WHICH THE ORIGINAL NYLON SHEET WAS INJECTION MOLDED

specimen revealed that it disappeared in the center of the specimen but that it could be observed again at the opposite end of it. The angle at which the cracks were oriented with respect to one another at the two ends of the specimen was about 90 degrees. The existence of erosion along cracks and between cracks seems to indicate that the cracks were there during part or during all of the time that the specimen was under test on the rotating arm.

The nylon sheet from which the rain erosion specimens were prepared was a circular plate formed by injection molding. There was a raised disk of the nylon plastics in the center of the circular plate at the point where the molten material had been forced through an orifice to form it. It was later observed that a vestige of this disk remained in the form of an outline of it at the extreme side of specimen 1289A. This outline is indicated with an arrow in Figure 3(c). Consideration of radial lines from the point at which the molten nylon was injected to form the original circular plastics sheet suggests the thought that the parallel cracks observed on the rain-eroded specimen may bear some relation to them; it suggests the thought that the more or less parallel cracks observed on specimen 1289A were produced as a consequence of residual stresses in the original sheet material. If the molten nylon was injected into a cold mold, concentric circles of stress around the point at which injection occurred may have been frozen in it. In the light of this possibility, the more or less parallel cracks may be a type of stress-crazing. It is possible that the cracks in specimen 1289A formed when the specimen was cooled after being molded. In this case they were present before rain impingement against the specimen took place during test on the rotating arm apparatus. On the other hand, they may not have formed until the impact load of the impinging waterdrops was applied.

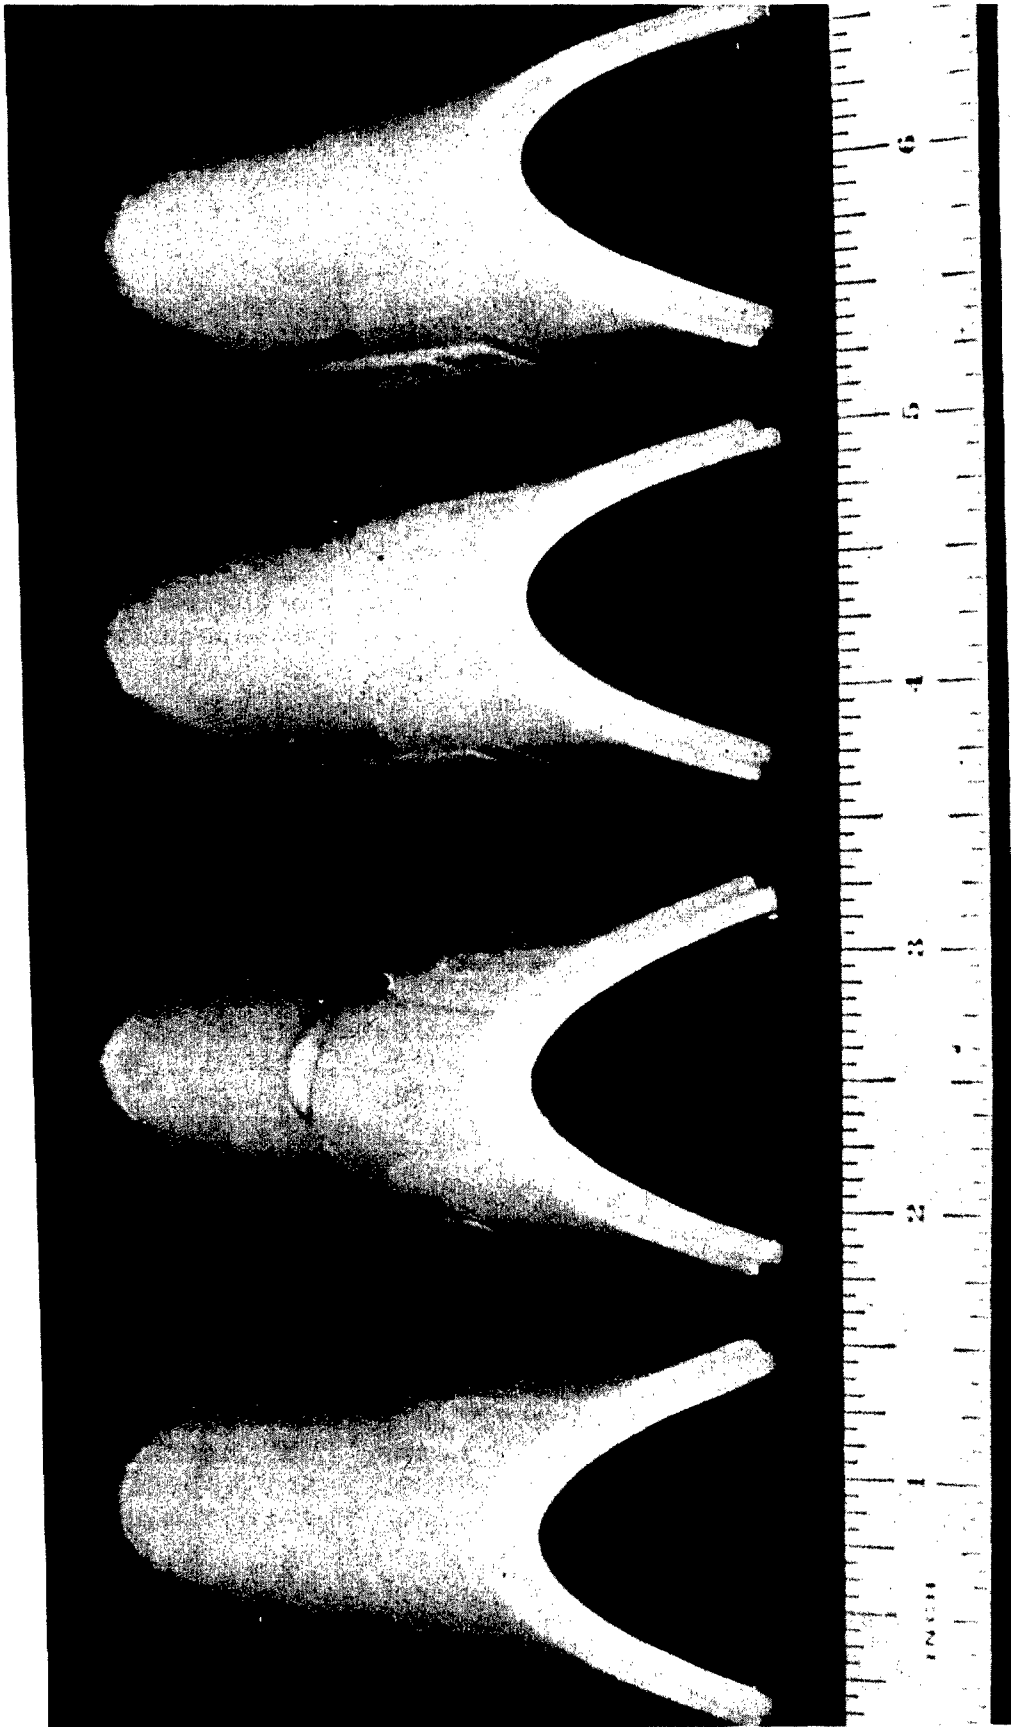
FIGURE 4. SPECIMENS OF NYLON FM-10001 AFTER VARIOUS TEST INTERVALS. STUDY III.

Microscopic examination of the flat specimen, 1497A, and of the airfoil-shaped specimen, 1495A, which had each been tested for 25 sec, produced the following observations. There were spots of etching on specimen 1497A, and scratches on the surface of this specimen were beaded with etch pits. In general, the density of fine blemishes and the number of scratches were greater on this specimen than on the original plastics sheet material. The surface of the leading edge of the airfoil-shaped specimen, 1495A, was more heavily etched than that of the flat specimen, 1497A, which was tested for the same length of time under the same conditions of velocity and rain rate. Spots of etching were more numerous on specimen 1495A than on specimen 1497A. This agrees with the observation that specimen 1497A was essentially as smooth to the touch as the original nylon sheet material, but the surface of the leading edge of specimen 1495A was roughened to the touch.

Specimen 1495A, which was molded under conditions specified by the manufacturer out of sheet material that had been given prior heat treatment to remove residual stresses, should be compared with specimen 1289A of Study I which was tested under the same conditions of impingement velocity and rain rate for the same length of time. Specimen 1289A contains stress cracks between which surface material has already chipped away. Specimen 1495A has suffered no such damage.

Microscopic examination of the flat specimen, 1497B, and of the airfoil-shaped specimen, 1495B, which had each been tested for 1 min produced the following observations. There was very little difference in the degree of etching on specimen 1497B, which had been tested for 1 min, and on specimen 1497A, which had been tested for 25 sec under the same conditions of velocity and rain rate. There was also very little difference in the appearance of the surface of the leading edge of the airfoil-shaped specimens, 1495B and 1495A, which had been tested for 1 min and for 25 sec, respectively, under the same conditions of velocity and rain rate. Specimen 1495B was smoother to the touch than specimen 1495A, although it had undergone test for twice as long.

Specimen 1495B, which was molded under conditions specified by the manufacturer out of sheet material that had been given prior heat treatment to remove residual stresses, should be compared with specimen 1289B of Study I, which was tested under the same conditions of velocity and rain rate for the same length of time. There is little difference in the extent of rain erosion damage on these two specimens. As was noted in Section 3.1, specimen 1289B was for some reason exceptional in that no stress cracks formed on it. Specimen 1289B had apparently been molded under temperature conditions that were nearly correct, for the color of this specimen was only very slightly different from that of the original nylon sheet.

Microscopic examination of the flat specimen, 1497C, and of the airfoil-shaped specimen, 1496A, which had each been tested for 5 min produced the following observations. There were scratches on specimen 1497C that were heavily etched with fine pits; there were quite a few spots that might be clusters of etch pits. In general, the density of background etching on specimen 1497C, the flat specimen which was tested for 5 min, was greater than that on specimen 1497B, the flat specimen which was tested for 1 min. This is in agreement with the observation that specimen 1497C was slightly roughened to the touch, whereas specimens 1497A and 1497B were essentially as smooth to the touch as the original nylon sheet material. On the surface of the leading edge of the airfoil-shaped specimen, 1496A, which was tested for 5 min, the scratches were more heavily etched with pits and there was a greater density of clusters of etch pits than on the surface of the leading edge of the airfoil-shaped specimen 1495B, which was tested for 1 min under the same conditions of velocity and rain rate. Specimen 1496A was as smooth to the touch as specimen 1495B and smoother than specimen 1495A.

Specimen 1496A, which was molded under conditions specified by the manufacturer out of sheet material that had been given prior heat treatment to remove residual stresses, should be compared with specimen 1345A of Study II which was tested under the same conditions of velocity and rain rate for the same length of time. The difference in rain-erosion damage done to these two specimens is remarkable. To visual inspection, specimen 1496A is undamaged, whereas specimen 1345A is in an advanced stage of erosion and contains a crack at one end that extends completely through the 1/8-in. thickness of the specimen. At the end of the 5-min interval of test, the effect of stresses in the original sheet material and the use of improper molding conditions in forming the test specimens is very remarkable. See Section 4 for photographs of these specimens.

As far as visual inspection is concerned, the surface of the airfoil-shaped specimens 1495A, 1495B, and 1496A, which were tested for 25 sec, 1 min, and 5 min, respectively, retained the glossy appearance of the original nylon sheet material. The surface of the leading edge of the airfoil-shaped specimen 1496B, which was tested for 30 min, was dulled to the unaided eye and was as rough to the touch as very fine sand paper. Microscopic inspection of this specimen showed that shreds of surface material were scuffed up on the leading edge; in many cases the material pulled up appeared to be hair-like tendrils of nylon. There were also clusters of very shallow pits on the leading edge of this specimen. There was still some gloss to the surface between these broken out spots. Various sizes of smaller shallow pits existed between the larger ones. At what must have been the high-speed end of the specimen, the broken out areas were almost merged or continuous, that is, very little space existed between them. In general, the broken out spots appeared to be preferentially elongated in the direction across the leading edge.

Specimen 1496B, which was molded under conditions specified by one manufacturer out of sheet material that had been given prior heat treatment to remove residual stresses, should be compared with specimen 1346B of Study II which was tested under the same conditions of velocity and rain rate for the same length of time. The difference in the rain-erosion damage done to these two specimens is astonishing. After the 30-min test interval at a velocity of 600 mi/hr in 1-in./hr artificial rain, specimen 1496B had suffered only a mild surface abrasion, but specimen 1346B was in a very serious state of damage. The erosion on specimen 1346B had cut through approximately half the total thickness of the specimen. See Section 4 for photographs of these specimens.
